TEST REPORT

Report No. :	RSZ200707810-SF		
Applicant's Name:	MAX INTERACTIVE INC		
Address:	17752 Mitchell N, Suite D Irvine, CA 92614,USA		
Product Type:	Extreme Shell for Microsoft Surface Pro 5/6/7 12.3"		
Model:	MS-ES-SP-G7-BLK		
Report Type:	Drop Test Report		
Test Method:	MIL-STD-810G method 516.6 procedure IV		
Test Engineer:	Denny Xu		
Test Summary	Sample No.	Test Item	Result
	S01	Drop test	PASS
Test Date:	2020-07-29 to 2020-07-30		
Report Date:	2020-07-31		
Reviewed By:	Andrew Luo		
Prepared By:	Bay Area Compliance Laboratories Corp. (Dongguan). No.69, Pulongcun, Puxinhu Industrial Area, Tangxia, Dongguan, Guangdong, China. Tel: +86-0769-86858888 Fax:+86-0769-86858588

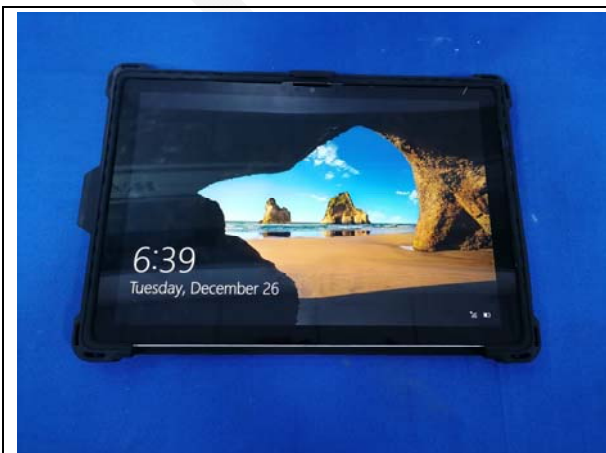
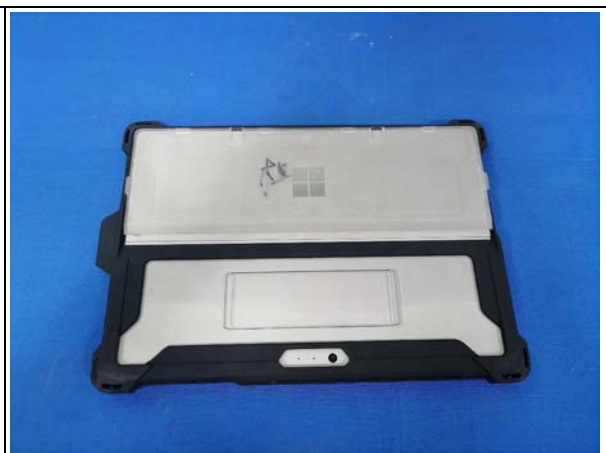
10. Sample Photos after the test

Sample No.	Test Result
S01	After the test, device function was normally. No change was found on the appearance of the case and device.
